NDI ID PA-00945  
PA DER 9-156

LAKE CAROLINE DAM

PHASE I INSPECTION REPORT,  
NATIONAL DAM INSPECTION PROGRAM.

FEBRUARY 1981

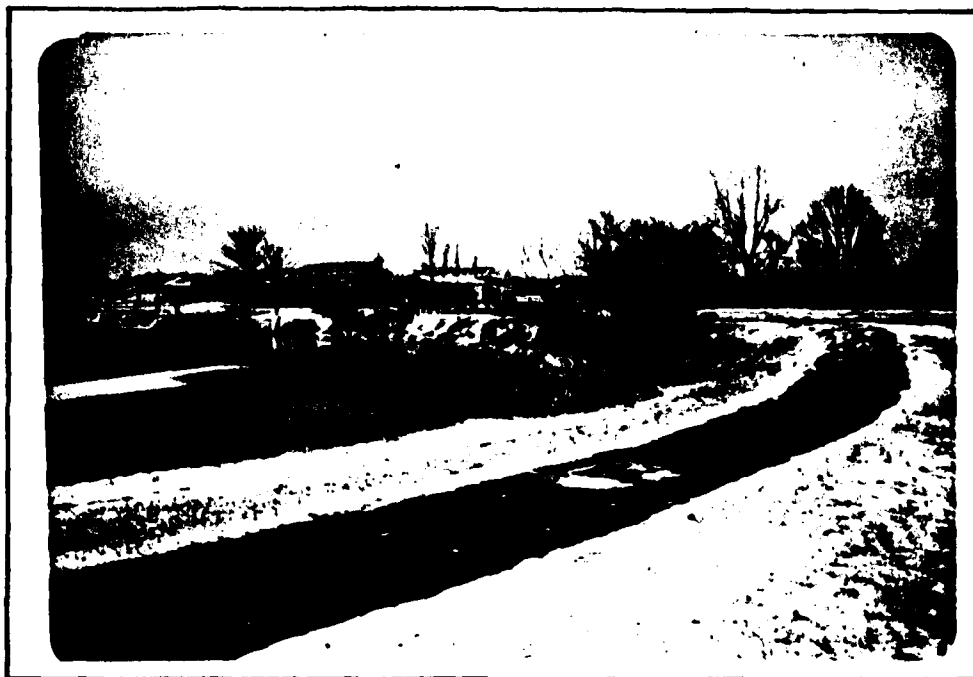
and small trees (up to 4-inch diameter trunks) growing on the upstream face create potential seepage paths through the embankment and endanger the integrity of the structure. The general condition of the embankment is considered to be poor, and the overall condition of the dam is considered to be fair.

1. UPSTREAM FACE OF DAM FROM THE WEST ABUTMENT SHOWING BRUSH AND TREES AND LACK OF RIPRAP. (12/16/80)

4. Bushes and small trees growing on the embankment should be removed. Any remaining voids should be backfilled with suitable, thoroughly compacted material.
